Evaluation Report 99

Vermeer 605E Round Baler

VERMEER 605E BALER

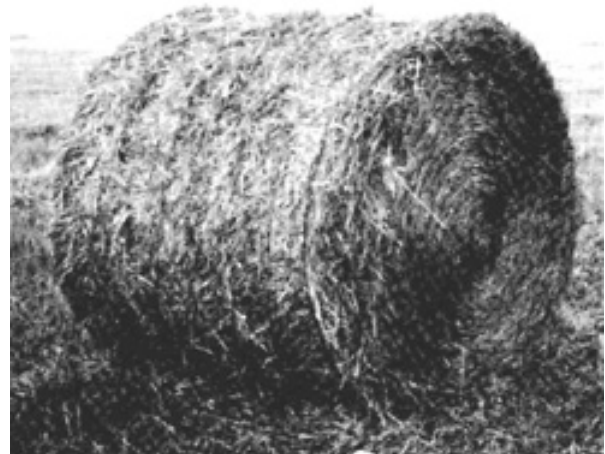
Bale Quality: The Vermeer 605E produced firm, durable bales (FIGURE 2) with flat ends, uniform density and uniform diameter. Bales averaged 1.6 m (63 in) in length and 1.7 m (67 in) in diameter. Average hay bales weighed from 400 to 680 kg (880 to 1500 lb) with an average density of 151 kg/m³ (9.4 lb/ft³).

FIGURE 2. Typical Hay or Straw Bale.

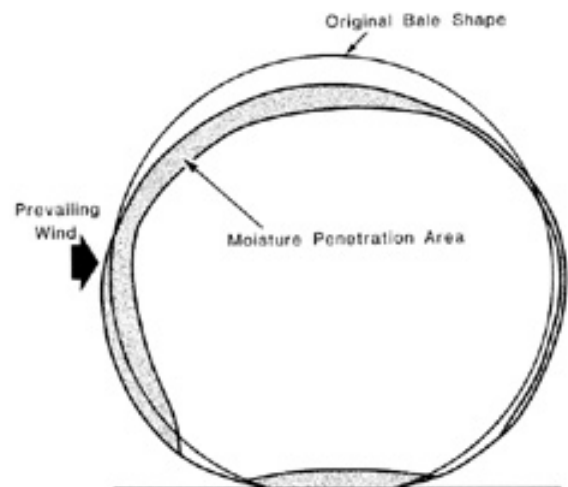
Bale Weathering: A common practice in the prairie provinces is to store round bales outside. FIGURE 3 shows the effect of weathering on a typical Vermeer 605E hay bale (bromegrass and alfalfa mixture) after 100 days of weathering. The weathering period was the time between baling and freeze-up. Bales were situated in a well-drained area with prevailing winds striking one side of the bales. During weathering, bales were exposed to about 75 mm (3 in) of rain and average prairie wind conditions.

The condition of weathered bales was good. The relatively high bale density and the well formed surface had kept moisture penetration to a maximum of 90 mm (3.5 in) on the windward bale side. Bales had retained 91% of their original height. As a result, bales were easy to pick with round bale handlers.

FIGURE 3. A Typical Hay Bale after 100 Days of Weathering.

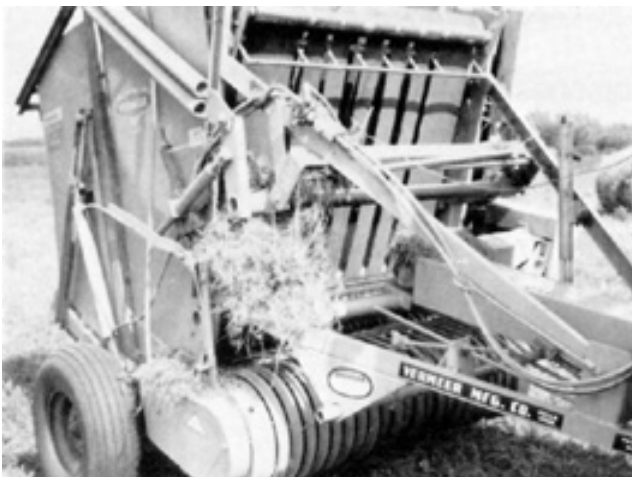
On several occasions, hay buildup on the tube lock (FIGURE 7) prevented proper latching. Hay restricted free movement of the tube lock and would not allow the twine tube to be lowered for bale wrapping. Hay buildup also interfered with the tube lock when returning the twine tube to the latched position. Modifications to the twine wrapping mechanism to reduce problems associated with hay buildup are recommended.

FIGURE 7. Hay Buildup on Twine Wrapping Mechanism.

1. Installation of pickup side shields as standard equipment.
2. Modifications to eliminate gate lock malfunction due to hay buildup.
3. Modifying the tying mechanism to reduce latching problems associated with hay buildup on the twine tube lock.
4. Modifying shielding to improve ease of servicing.
5. Installation of mechanical gate cylinder locks to improve operator safety while servicing the baler with the gate in raised position.
6. Modifications to eliminate interference between the bale starter roller and the pickup teeth when the pickup is in transport position.

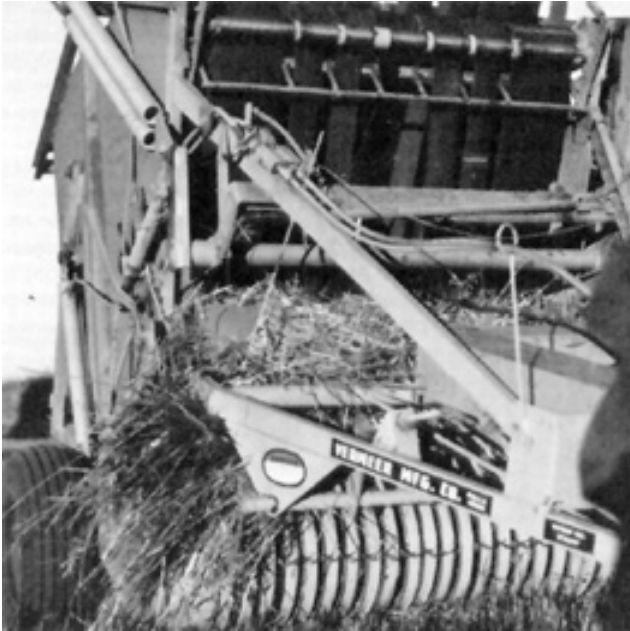
The long coarse-stemmed hay also sometimes caused pickup plugging (FIGURE 9). While filling the bale ends by feeding the windrow at the extreme edges of the pickup, the long hay hair-pinned on the baler side members causing the pickup drive belt to slip. Use of the optional pickup side shields should reduce this problem.

FIGURE 9. Hair-pinning of Long Hay on Baler Side Members.
